Manhole Inspection Summary

Manhole # S23GG1009MH

Location Address: **1325 42ND ST**

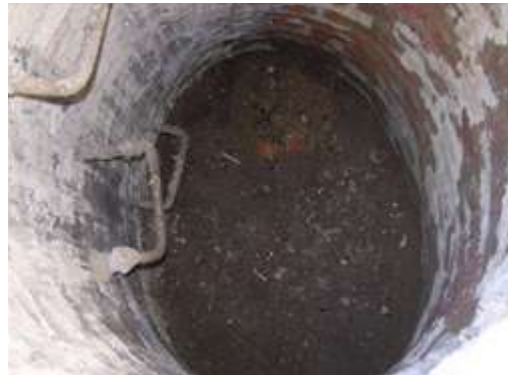
Top View

Channel debris.

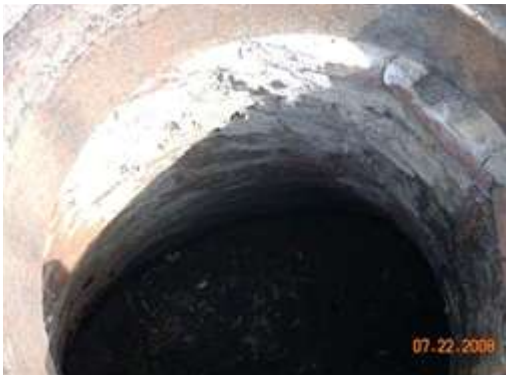
Defect

Frame leaks. Frame offset. Adjustment deterioration and infiltration. Barrel infiltration - other side.

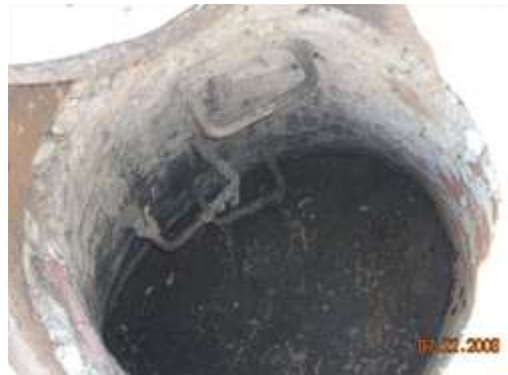
Defect

Frame leaks. Frame offset. Adjustment deterioration and infiltration. Barrel infiltration.

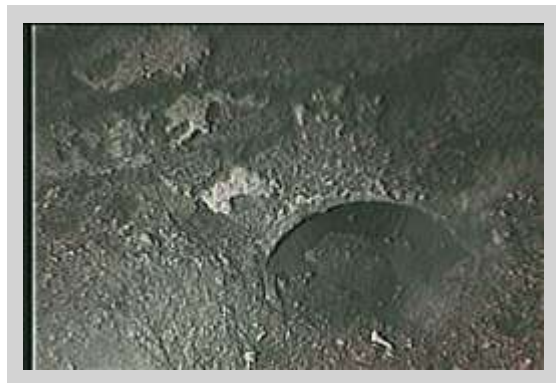
Pipe Out @ 12 O'Clock

Deposits: ☐ None ☒ **Mud** ☐ Sludge ☒ **Debris** ☐ Grease

Silt Depth: **3** (in.)

Deposits Extent: **Medium**
